Debris/Ice/TPS Assessment And Photographic Analysis For Shuttle Mission STS-38

February 1991

DEBRIS/ICE/TPS ASSESSMENT
AND
PHOTOGRAPHIC ANALYSIS
OF
SHUTTLE MISSION STS-38

November 15, 1990

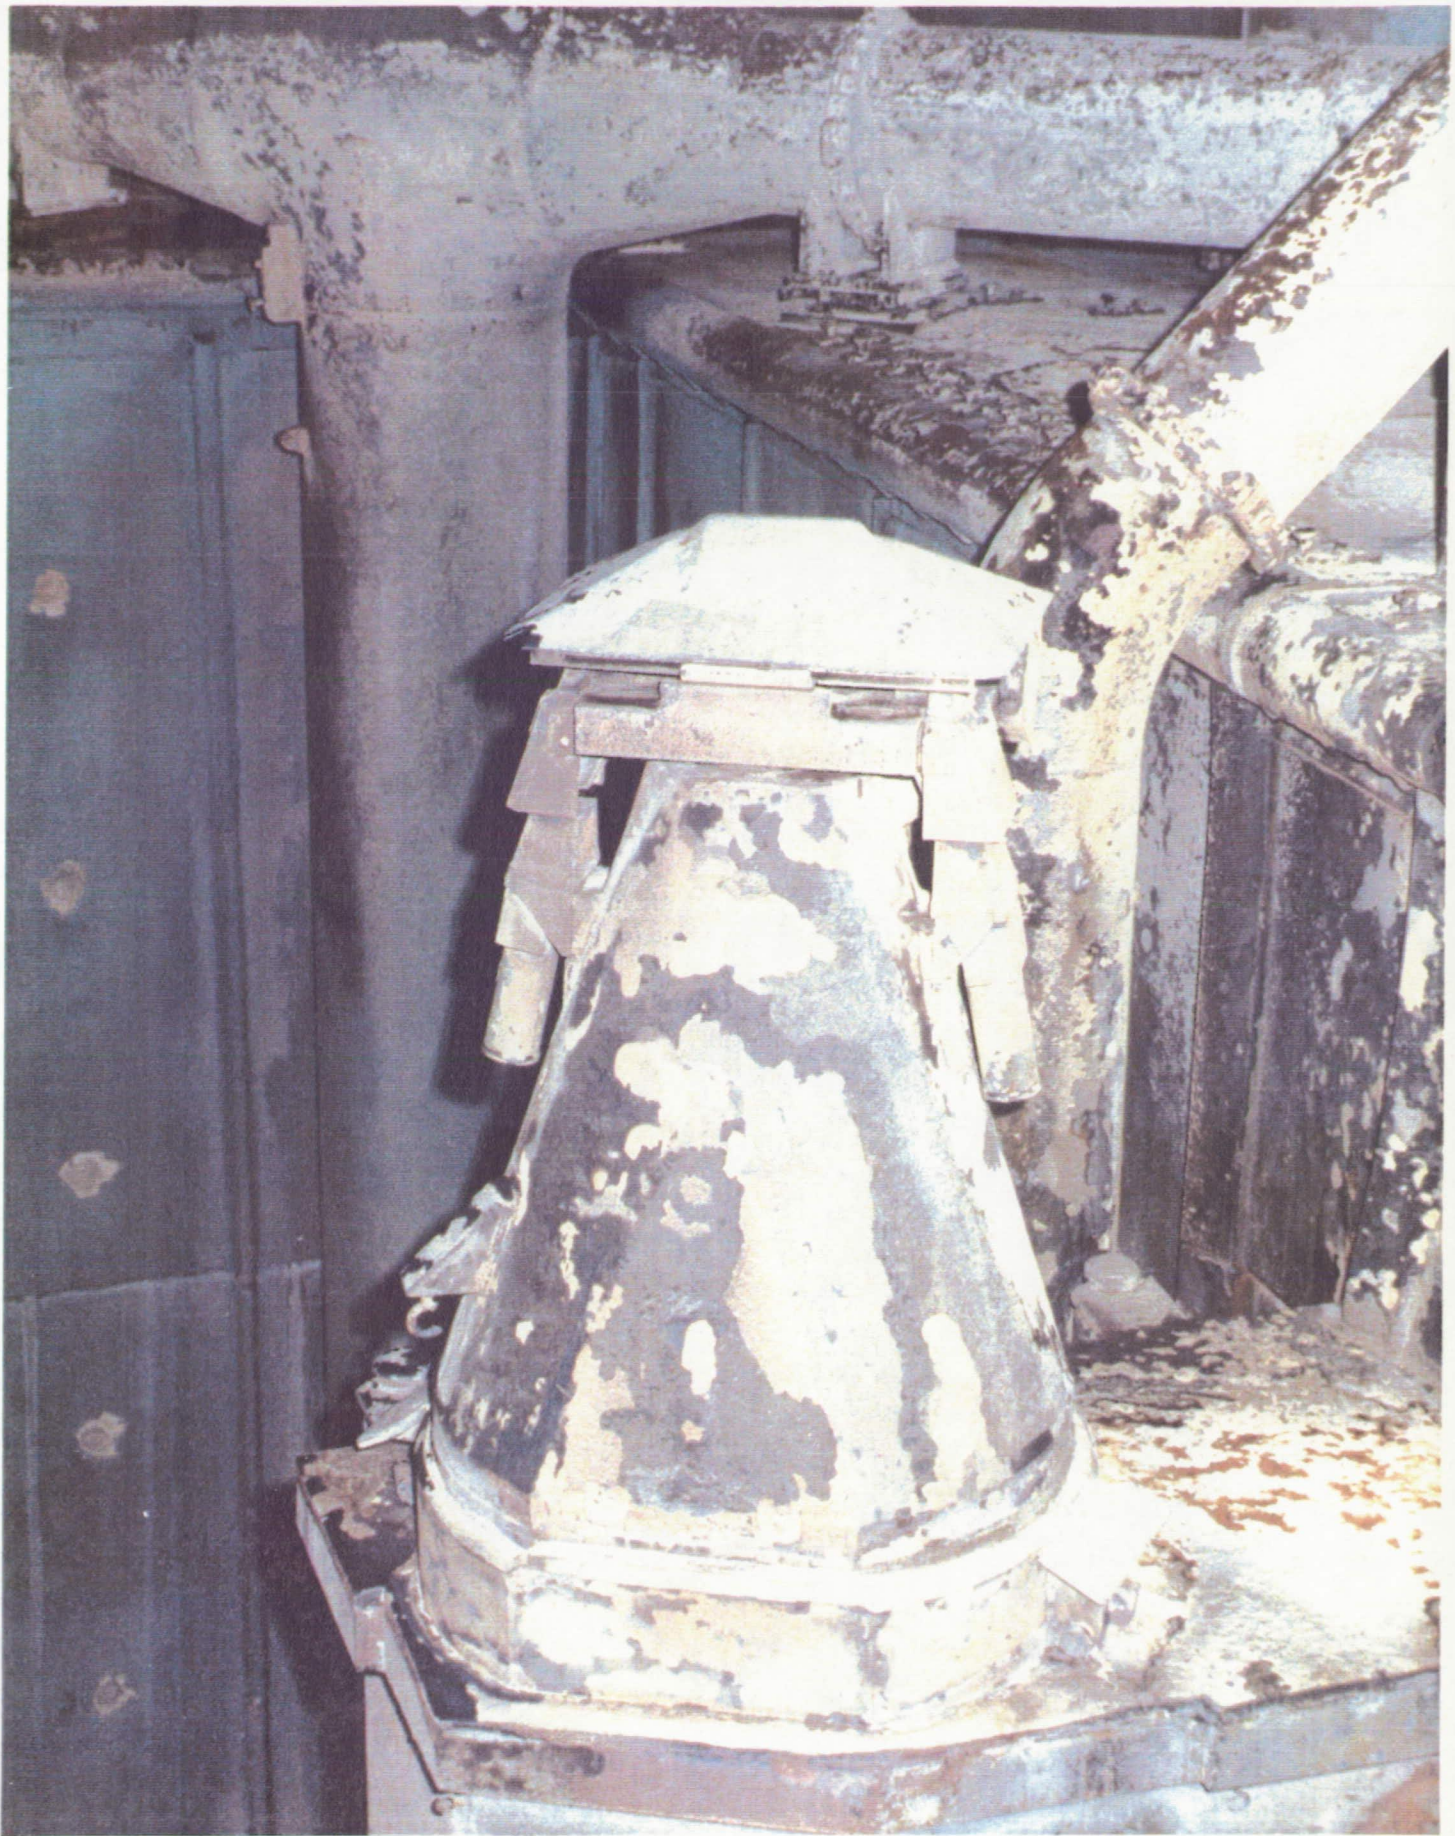
Typical SRB plume erosion on north holddown posts. All doghouse
blast covers had closed properly.

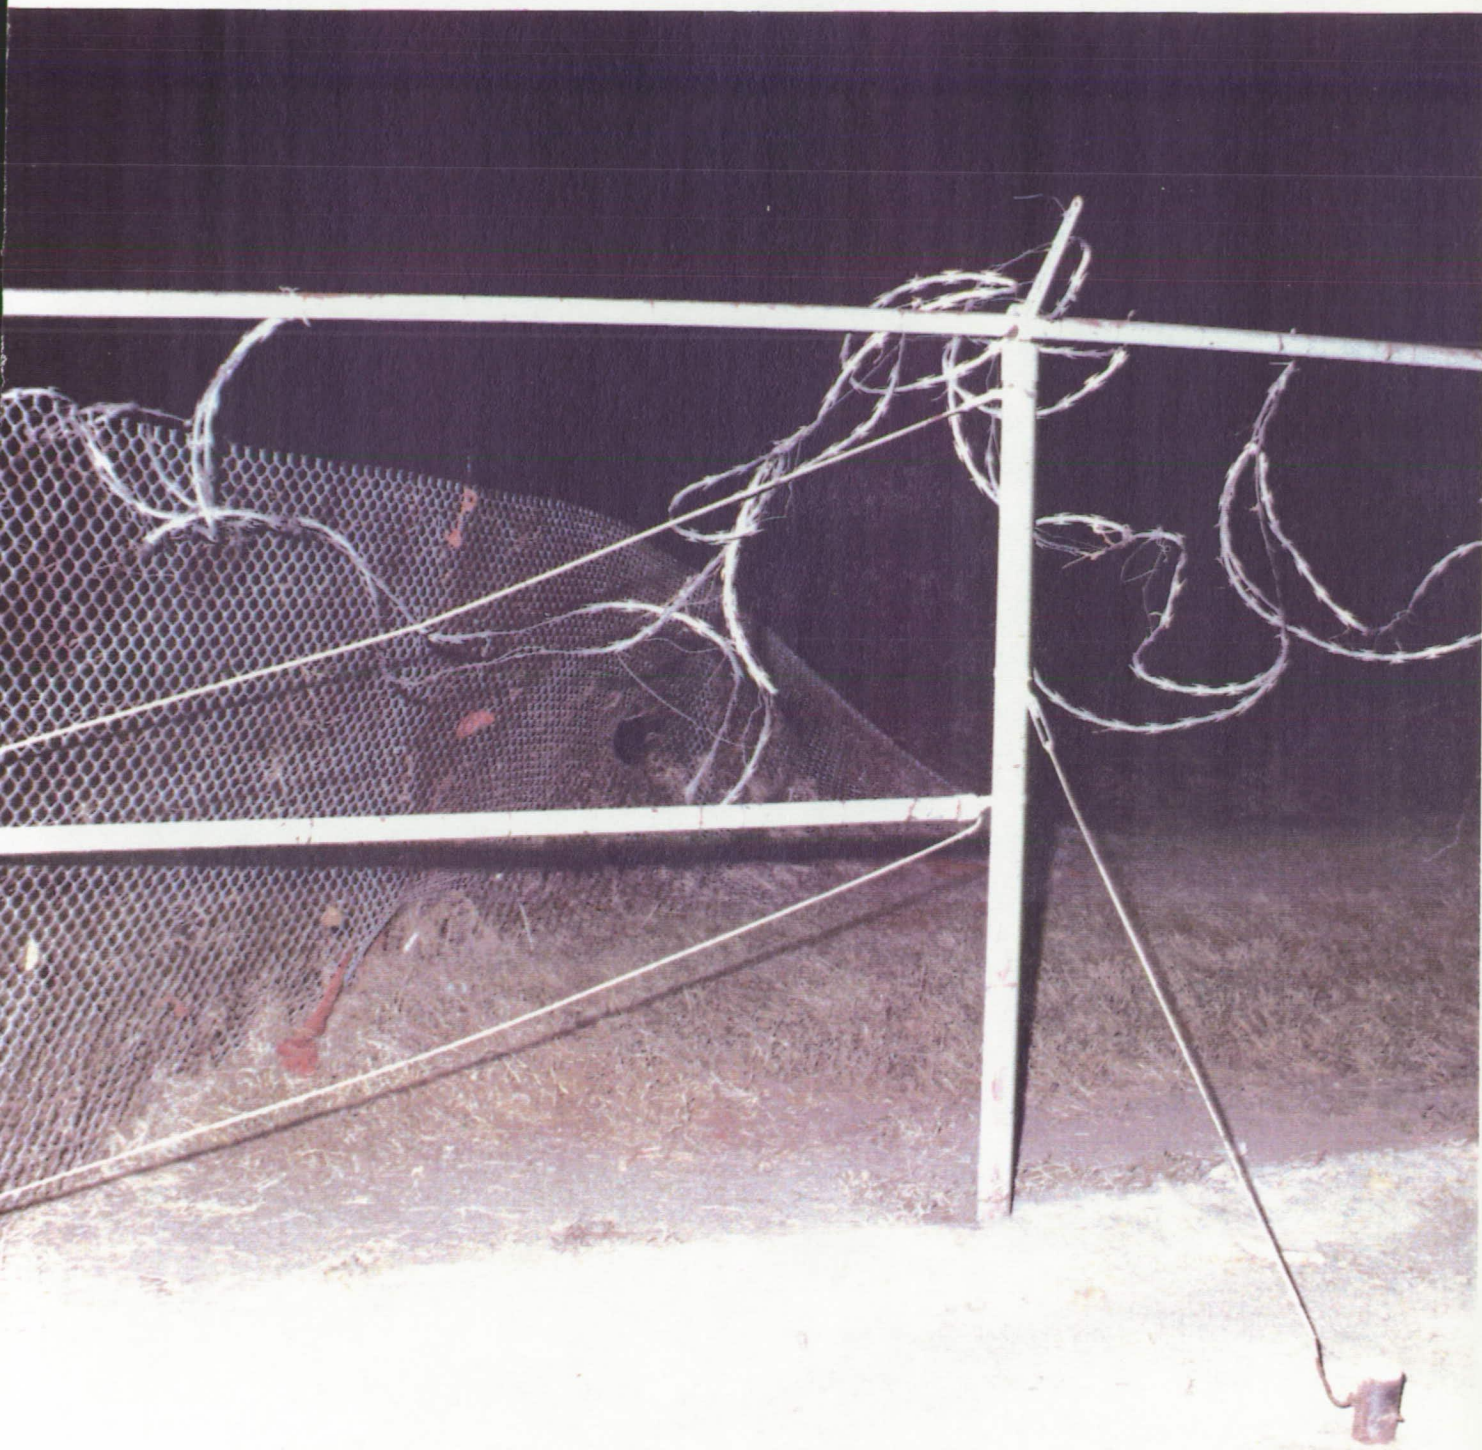
SRB exhaust plume from the pad flame trench caused damage to
the north pad perimeter fence

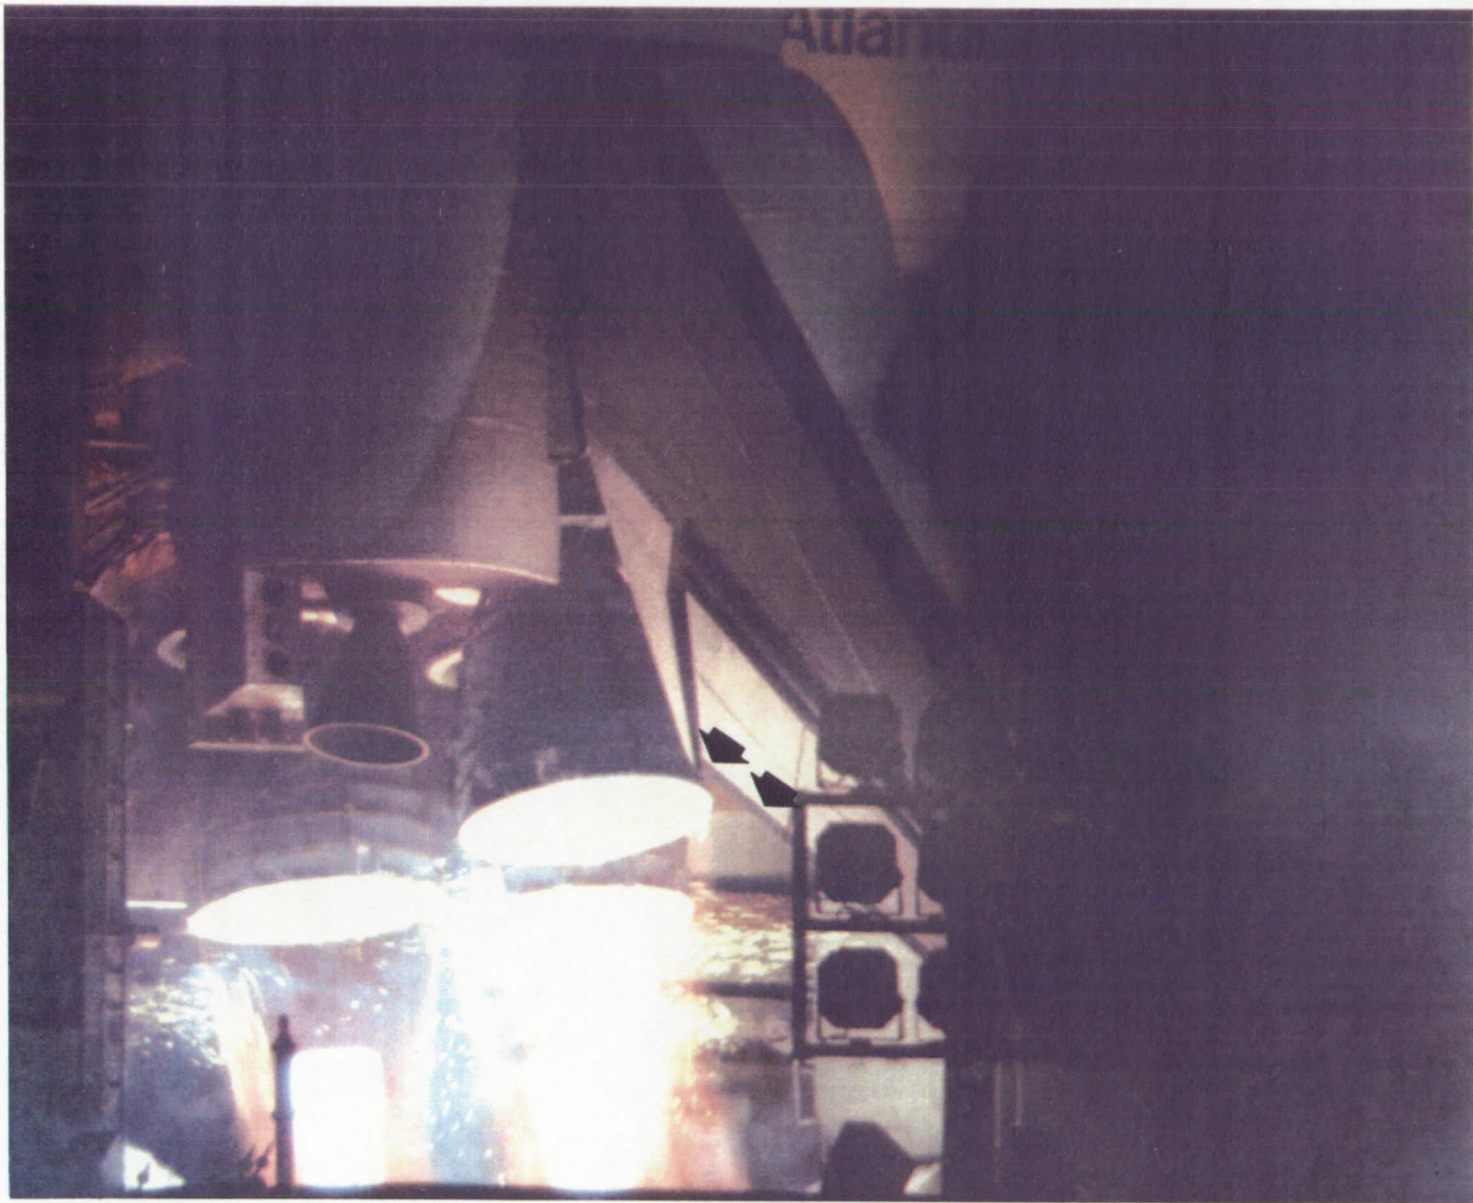
SSME ignition vibration/acoustics caused pieces of tile surface
coating material to fall from rudder/speed brake trailing edge
tiles (arrows)

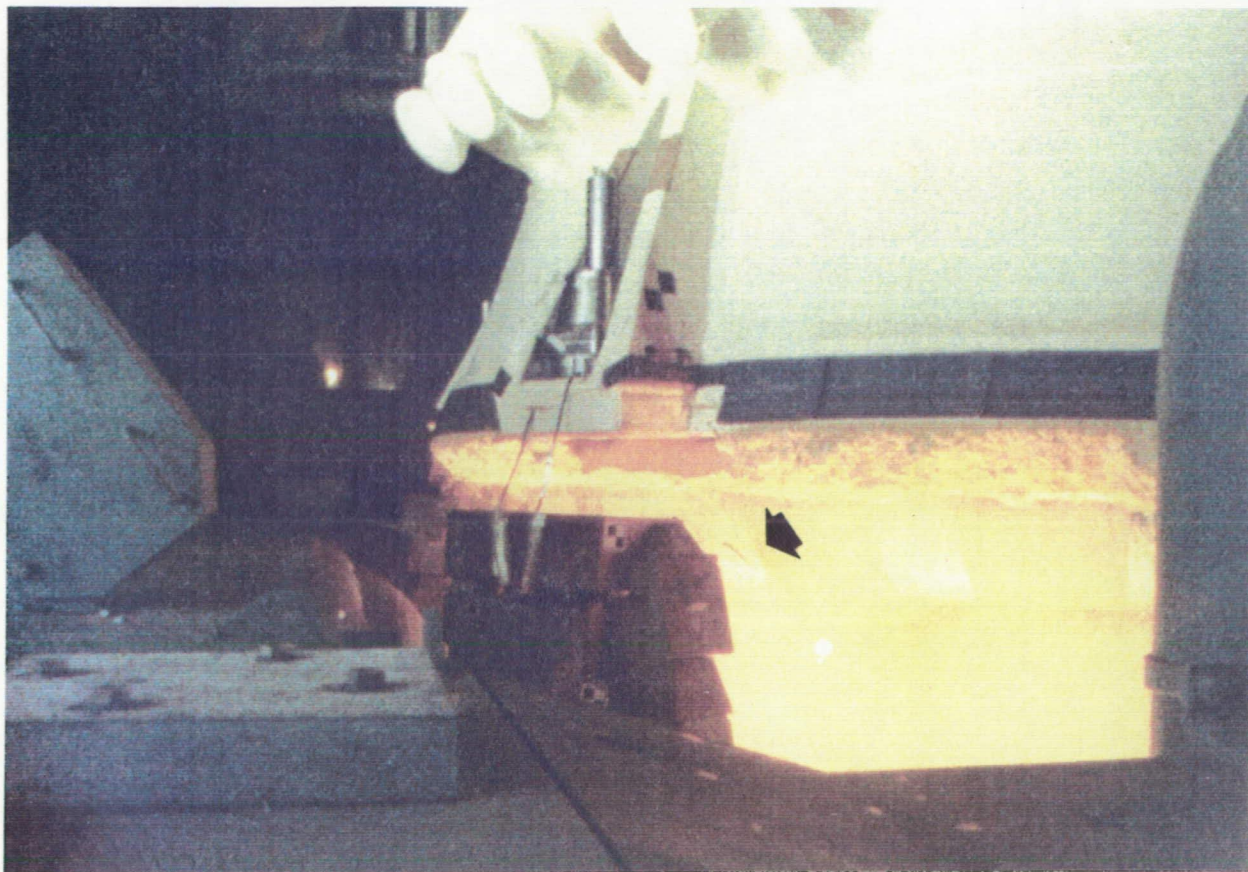
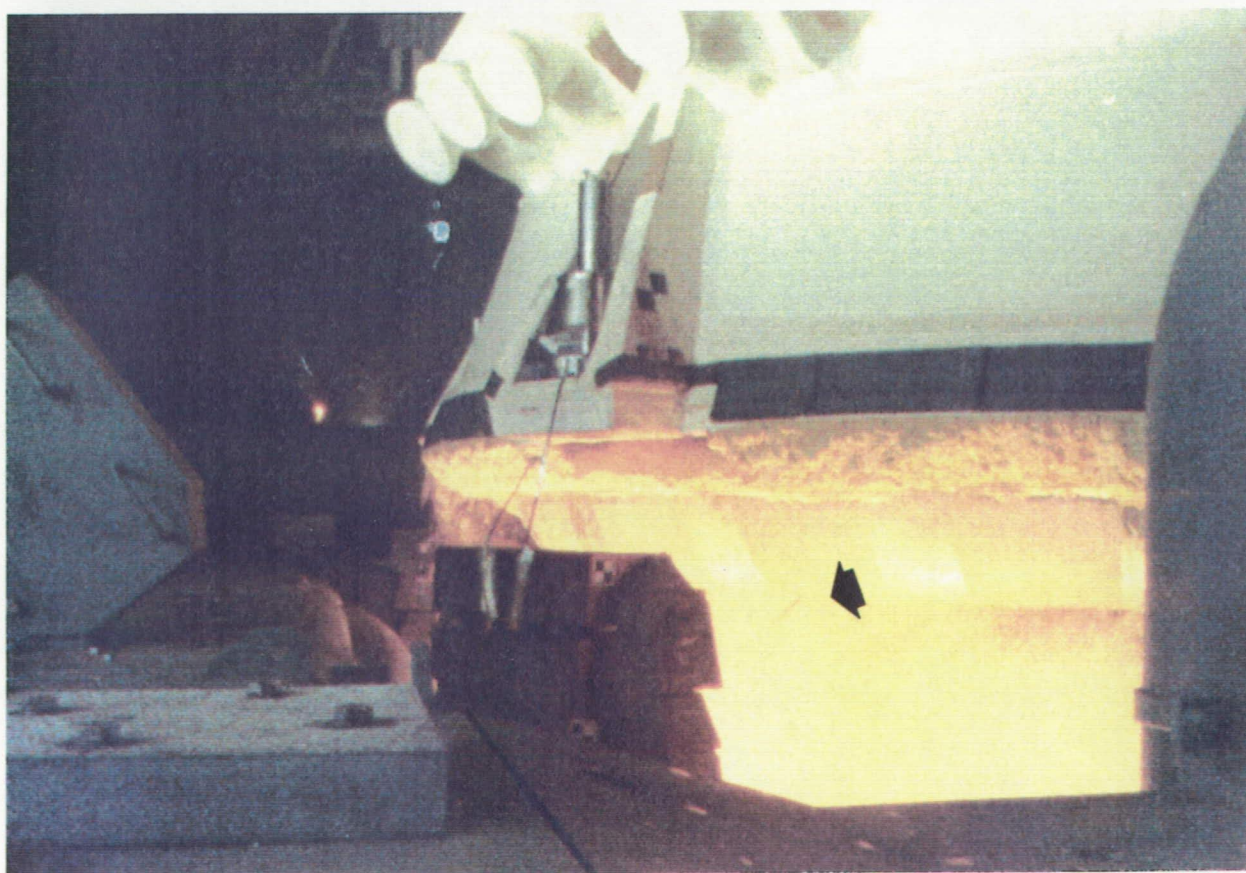
Small pieces of aft skirt instafoam and a sliver of HDP shim material/putty were pulled loose from the HDP #5 area at T-0

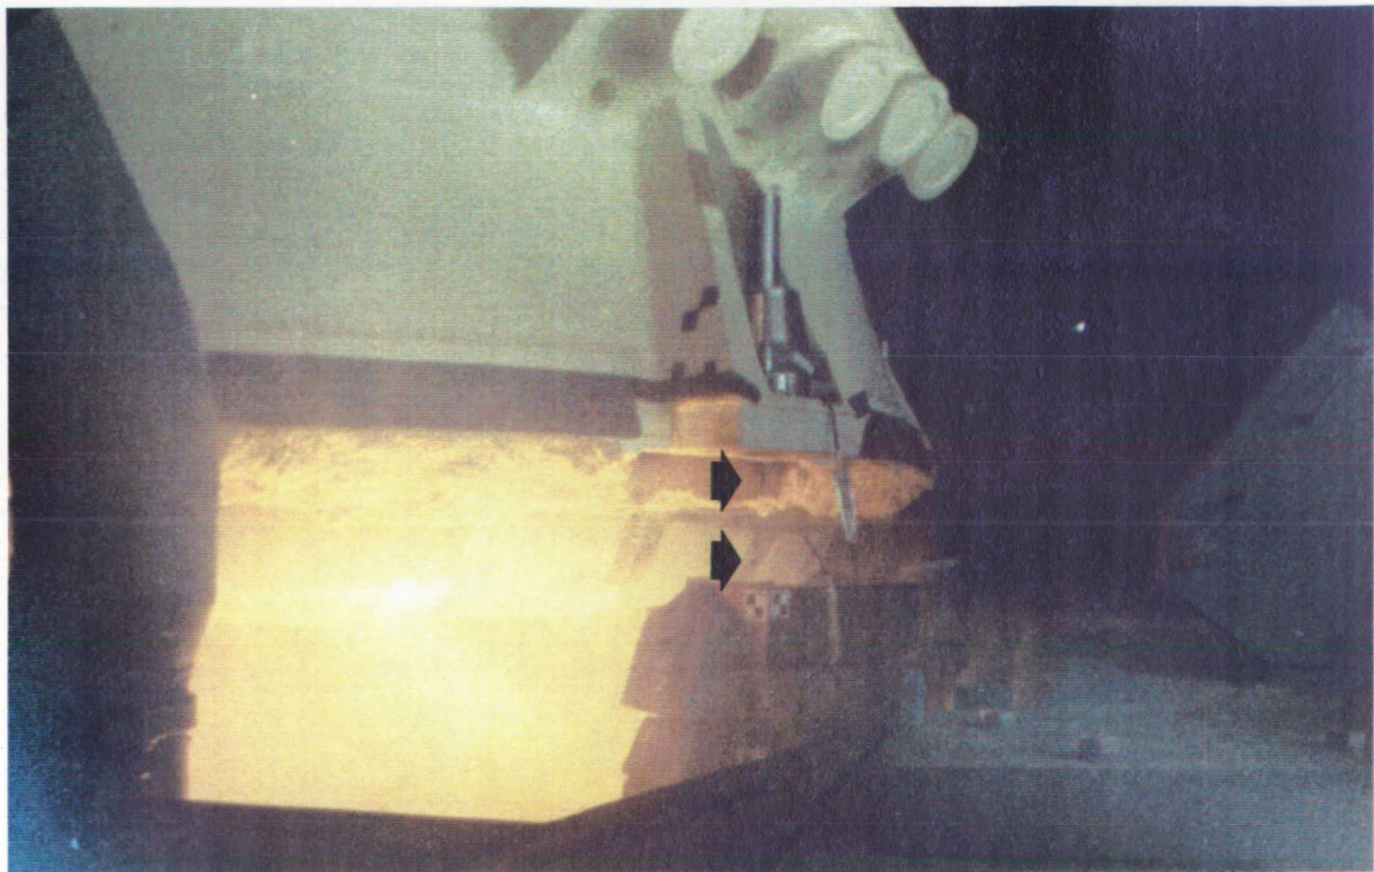
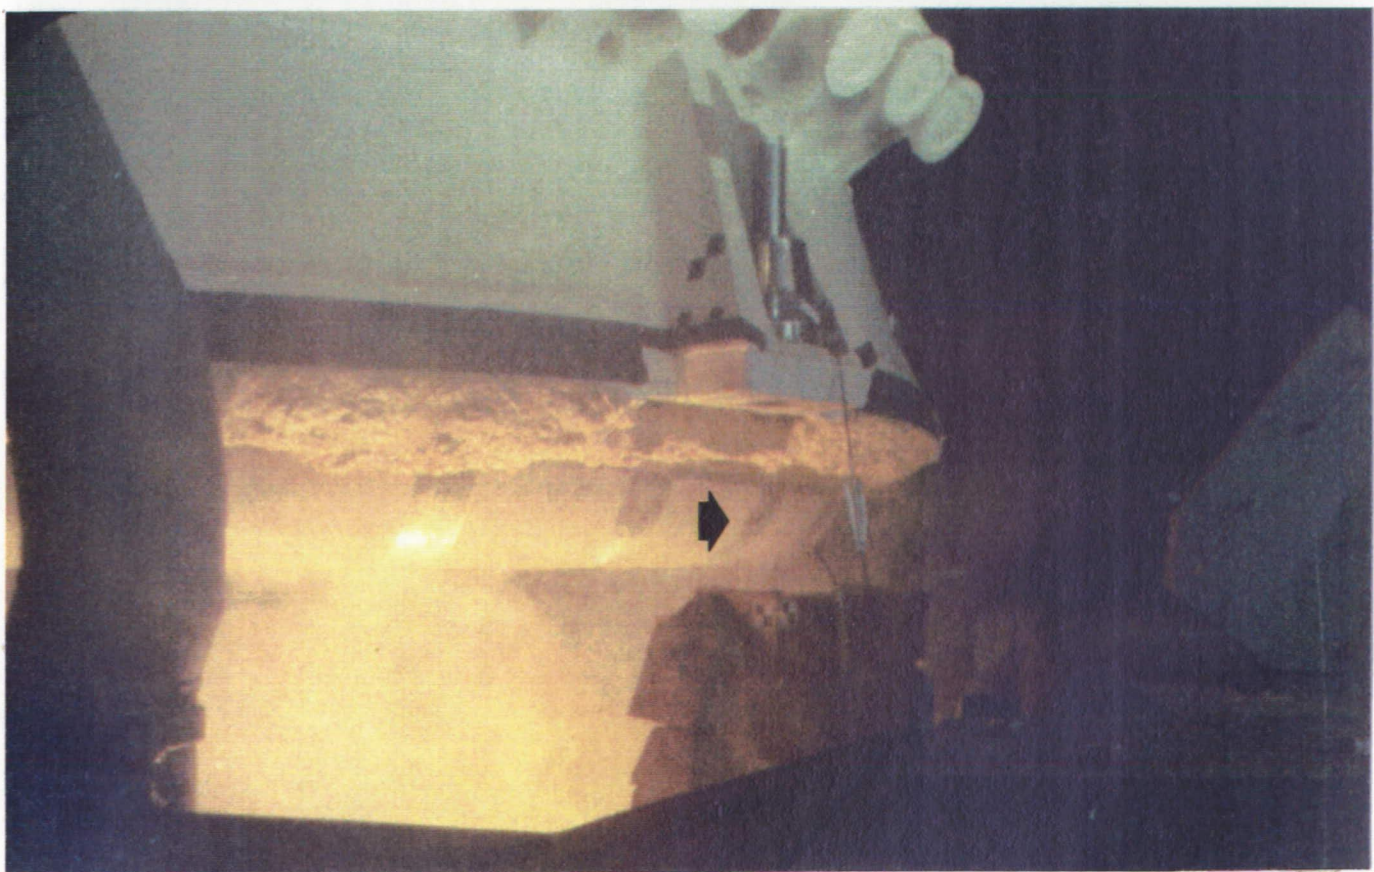
Three ordnance fragments fell from the RH SRB aft skirt HDP #1
DCS/stud hole shortly after liftoff

The minimum allowable retention per NSTS-07700 is 90 percent. Loss of ordnance fragments from the HDP #1 DCS was visible in the film review, but no debris was observed falling from the HDP #7 DCS. All DCS plungers had been fully seated when inspected at Hangar AF. Disassembly of the DCS's revealed no installation anomalies.

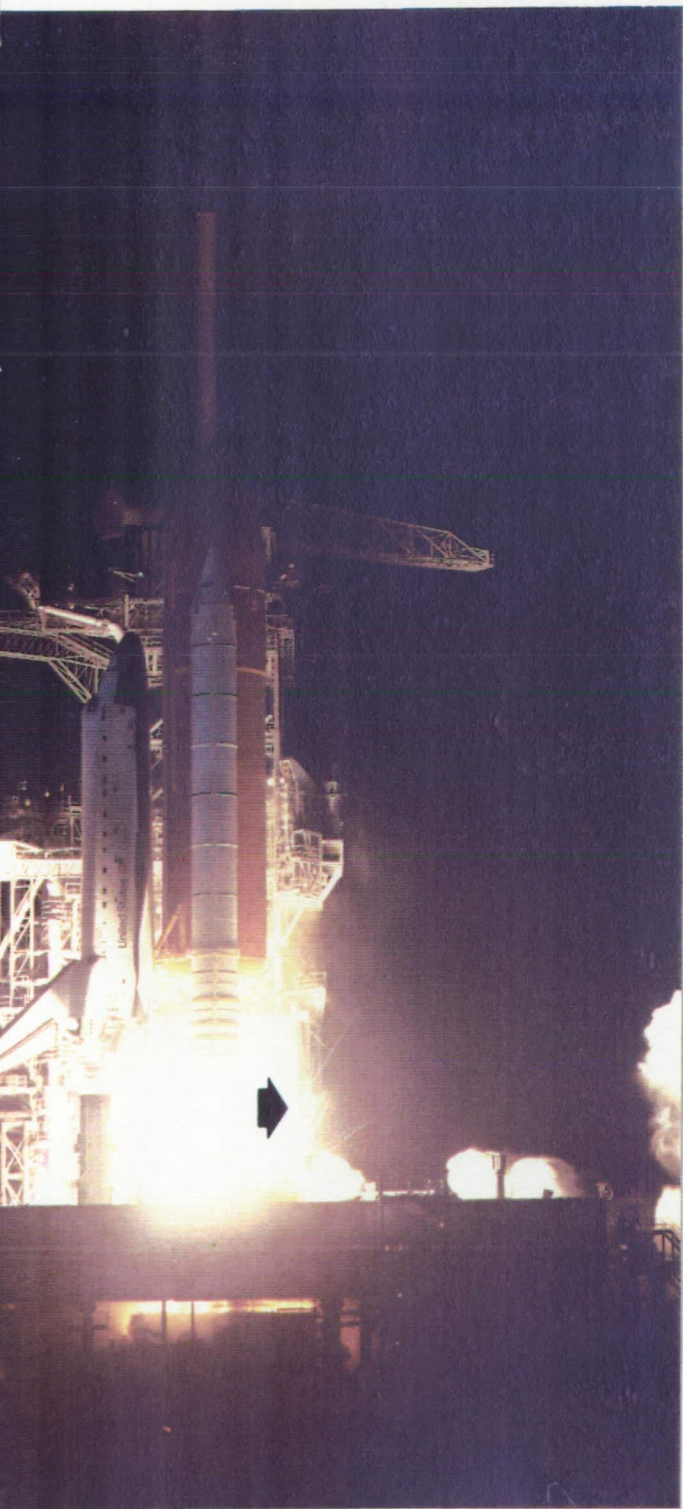
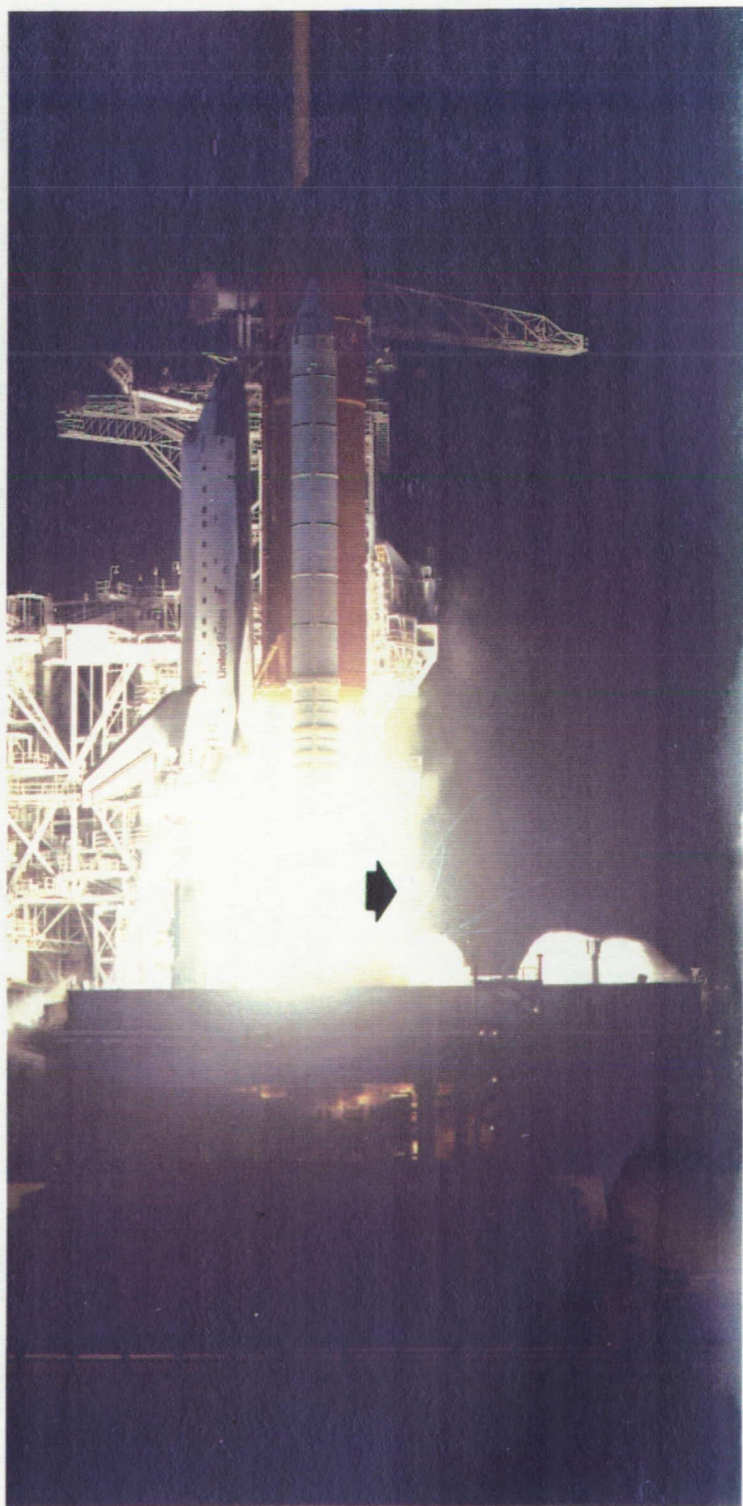
Numerous particles were ejected out of the SRB exhaust holes after T-0 as the vehicle attained 30 feet altitude. Five of the particles trailed smoke and may be pieces of burning SRB throat plug material. Charred pieces of throat plug are commonly found on the pad after launch.

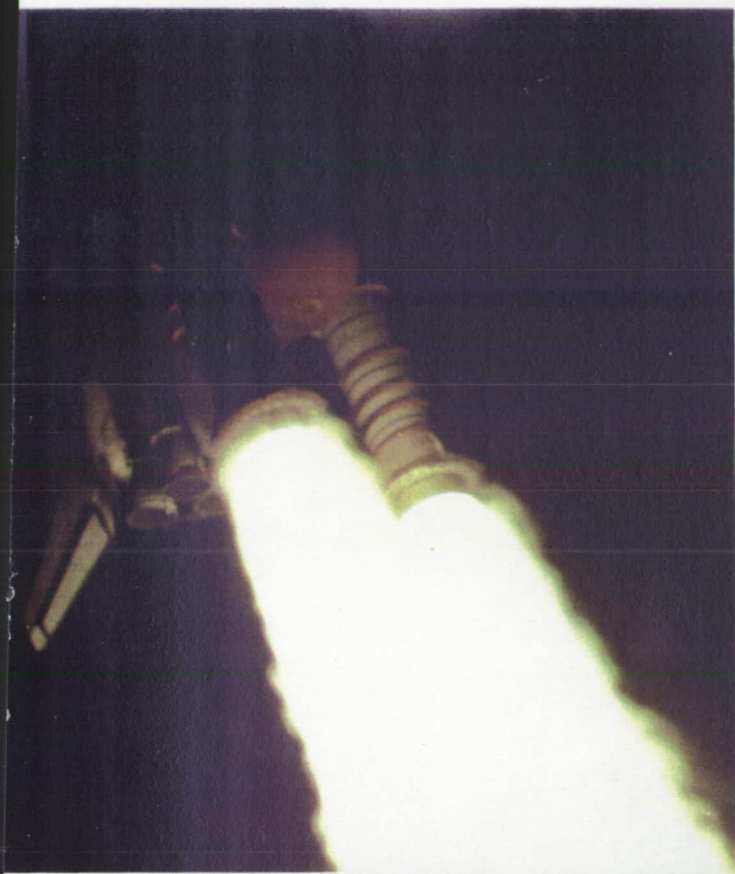
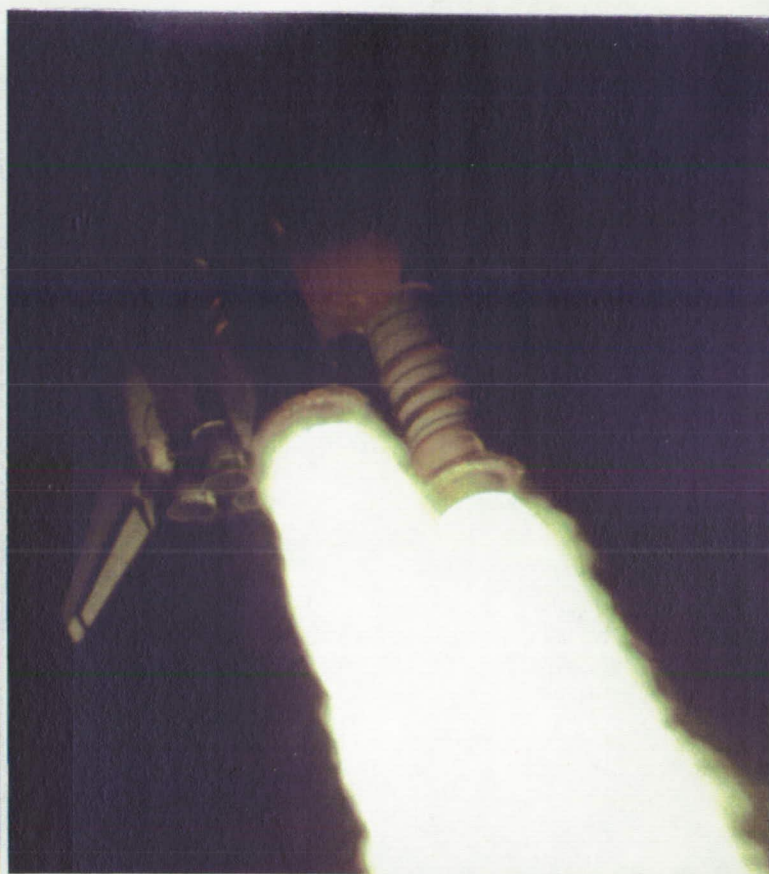
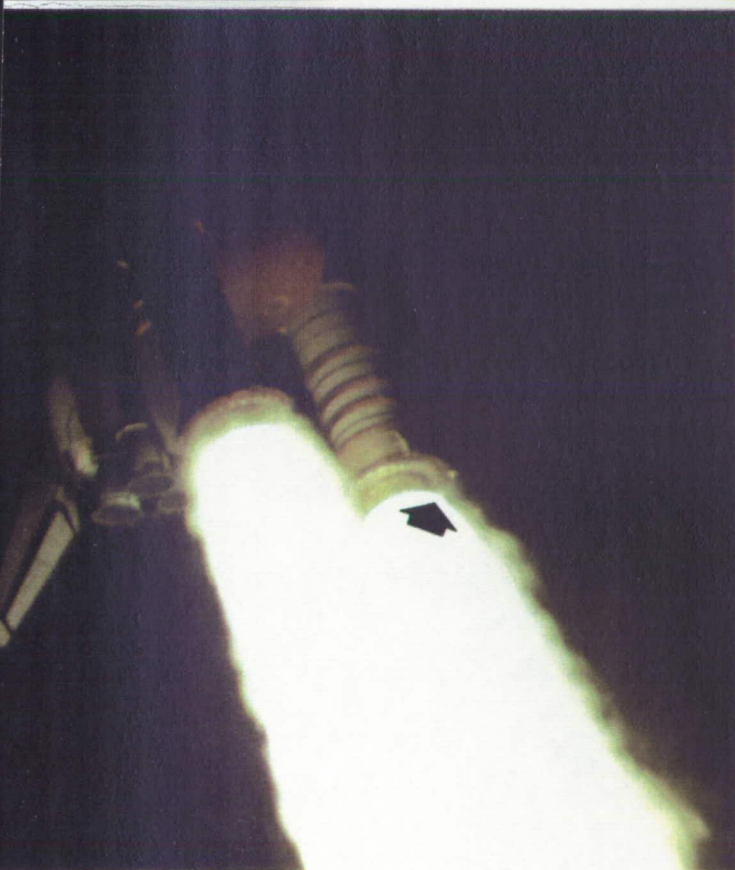
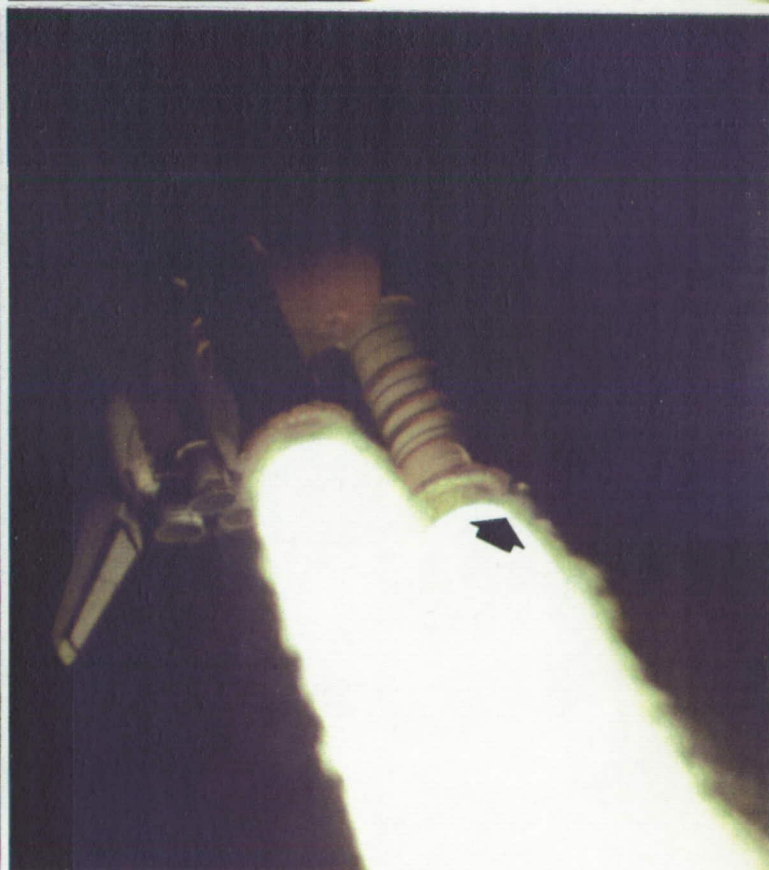
Possible loss of thermal curtain material from the LH SRB aft skirt -Z side. Tracking footage shows the piece of material appeared to come loose near the nozzle extension, moved out toward the aft ring, and then separated from the aft skirt.

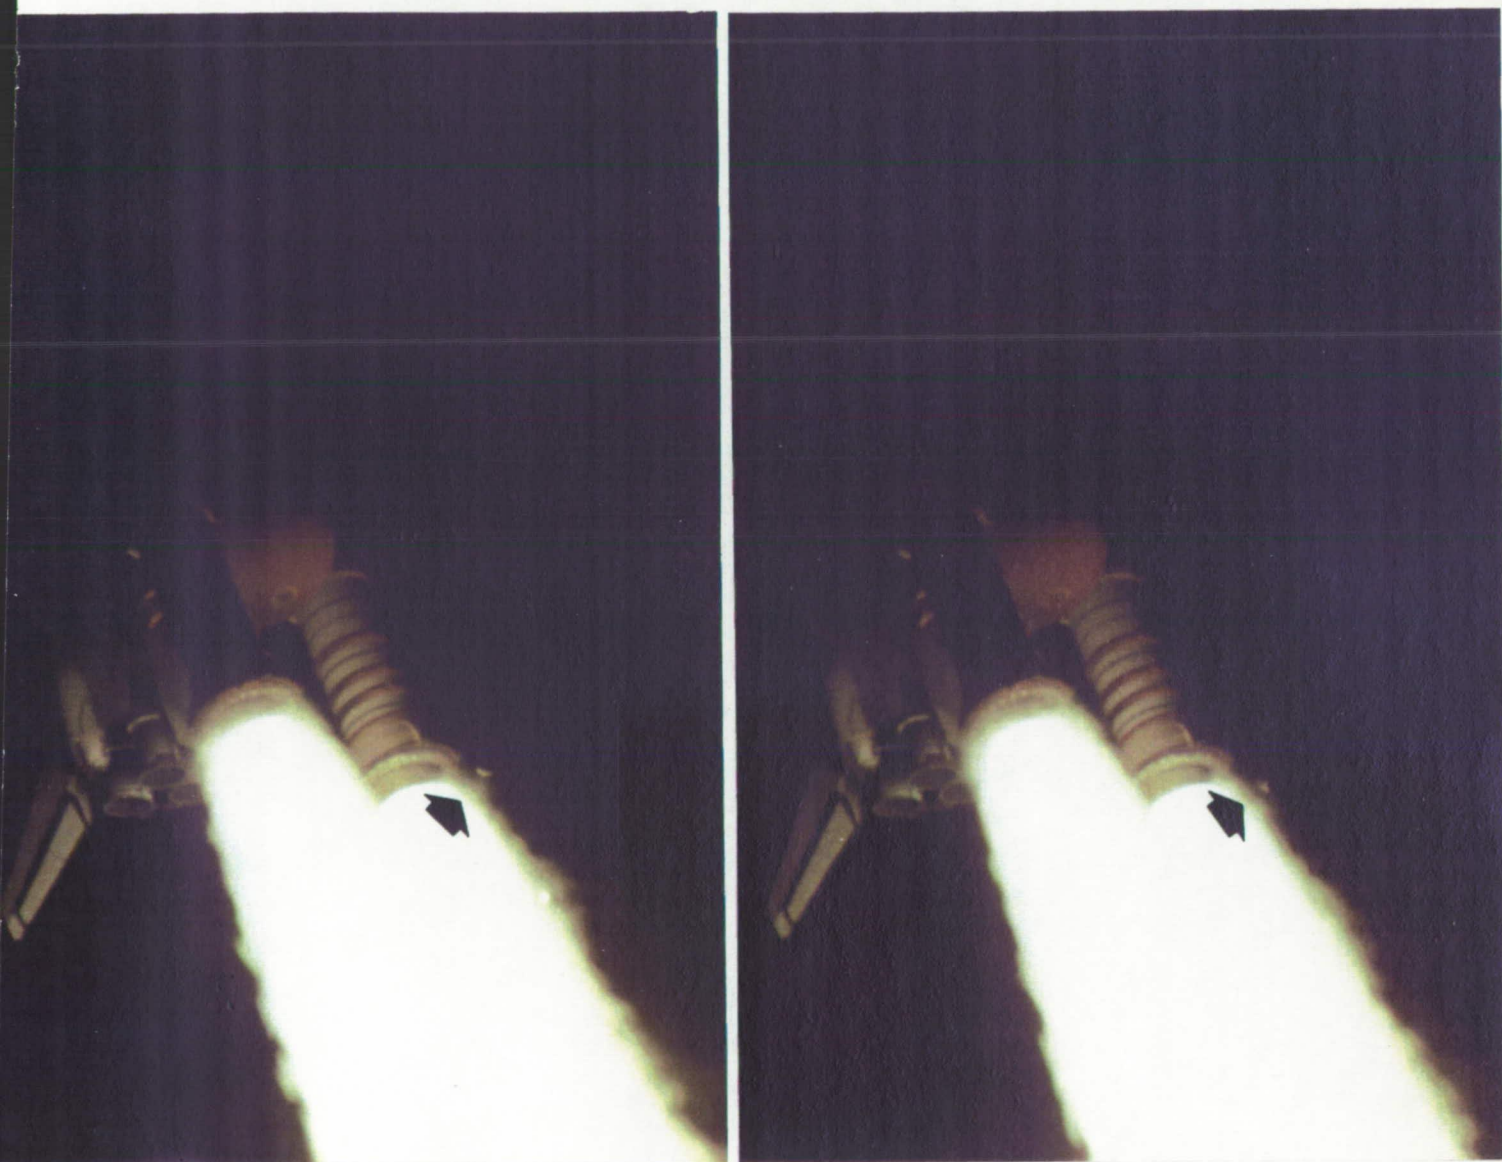
Possible loss of thermal curtain material from the LH SRB aft skirt -Z side at 34 seconds MET. The piece of material was lost against the SRB exhaust plume and could not be tracked further.

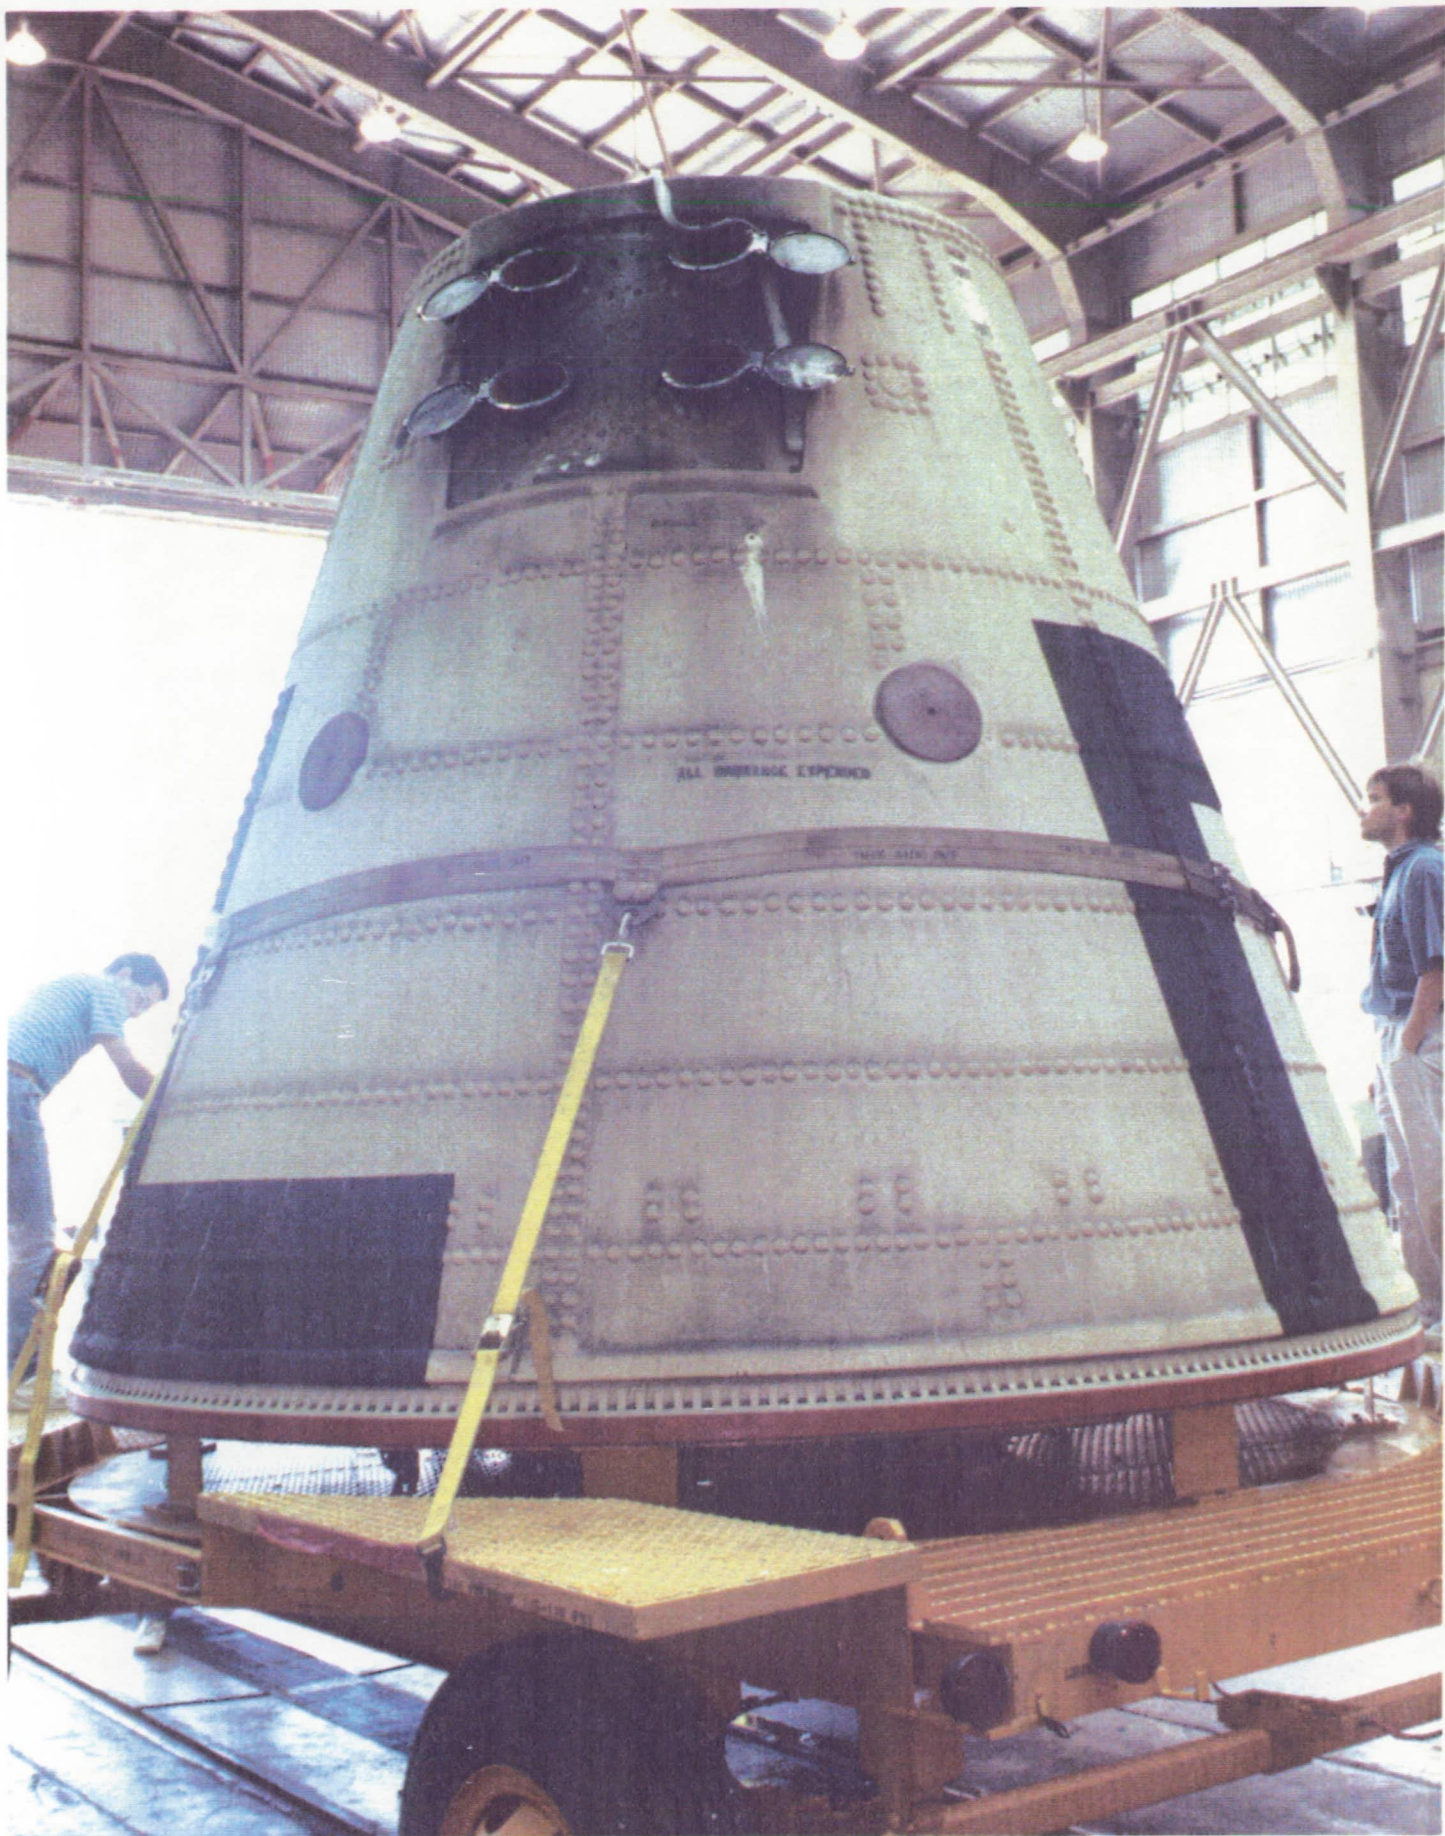
Post flight condition of the RH SRB frustum. There were 56 MSA-2 debonds over fasteners, but no areas of missing TPS

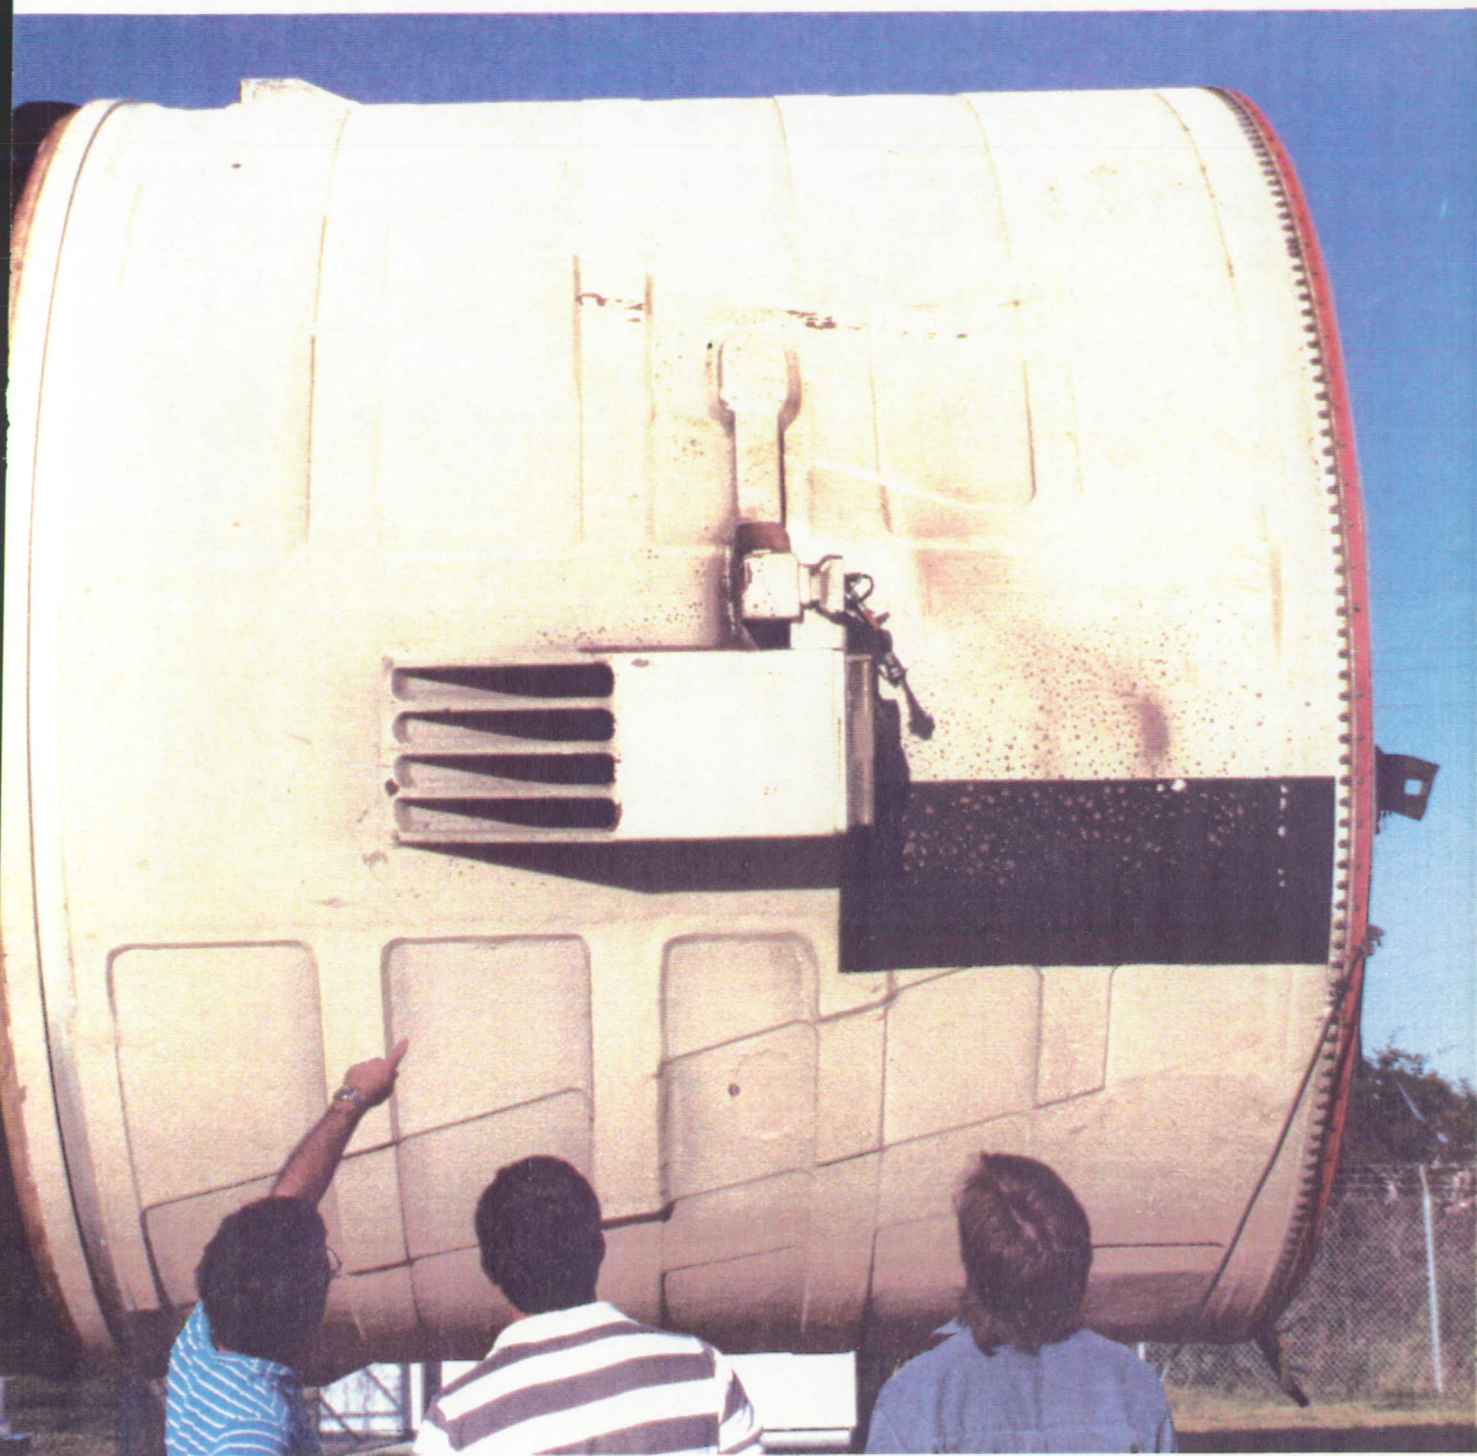
Post flight condition of the RH SRB forward skirt. There were
no MSA-2 debonds or areas of missing TPS
